DEC-TECHNICAL BULLETIN

Bulletin No: TB004 Version: v.02

Subject: BITUMINOUS PRODUCTS COMING IN CONTACT WITH DEC-TEC MEMBRANES

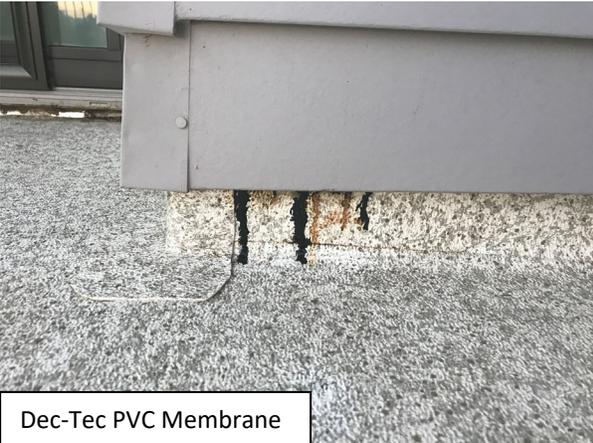
Issue: Brown to black streaking and staining can occur when bituminous and or asphaltic building products come in contact with Dec-Tec PVC membranes.

Dec-Tec PVC Membrane

How to prevent this from happening: Create a 'bond breaker' between the asphaltic membrane and the PVC membrane. This is achieved via one of the following strategies, but not limited to:

- 1.) Utilizing aluminum foil tape, straddle it over the upper edge of the PVC membrane that is to be a minimum of 6" up the vertical wall. When straddling it, half the width of the aluminum foil tape should be on the PVC membrane, and half should be on the siding substrate which, in most cases, is OSB board. Then, bring your asphaltic waterproof membrane right to and on the aluminum foil tape which is over the PVC membrane. Using a minimum 4" wide aluminum foil tape is suggested.

- 2.) Utilizing a thin gauge flat metal strip, mechanically fasten it into the siding substrate where you would see it straddle over the upper edge of the PVC membrane that is to be a minimum of 6" up the vertical wall. When straddling it, half the width of the thin gauge flat metal strip should be on the PVC membrane, and half should be on the siding substrate which, in most cases, is OSB board. Then, bring your asphaltic waterproof membrane right to and onto the thin gauge flat metal strip, ensuring to cover the fasteners used to hold the strip, which is over the PVC membrane. Using a minimum 4" thin gauge flat metal strip is suggested.

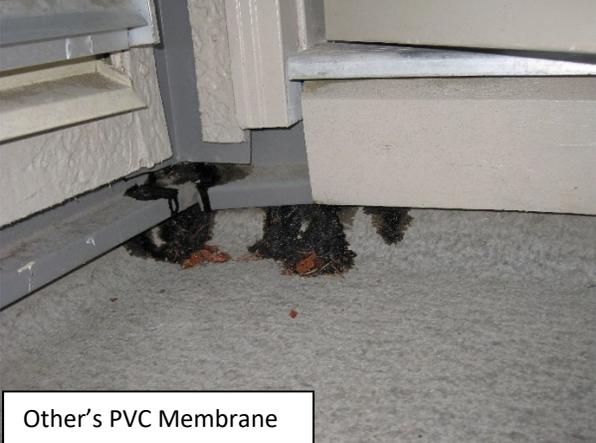
Other's PVC Membrane
